Kern Water Bank Authority

Habitat Conservation Plan/

Natural Community Conservation Plan

2012 Compliance Report and 2013 Management Plan

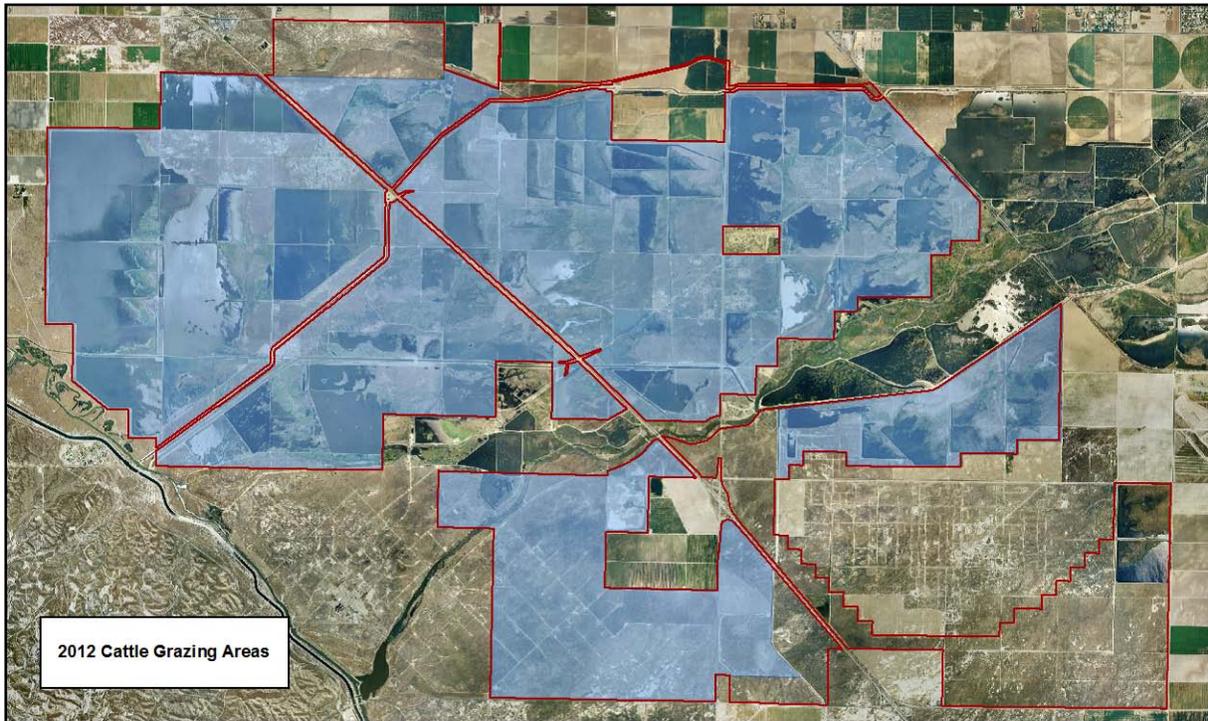
Figure 2. Areas grazed by cattle in 2012.

Although precipitation in the winter of 2011-2012 was below normal, late rains provided favorable conditions for tumbleweed growth. In addition, drying recharge ponds provided ample moisture for significant plant growth in pond bottoms. As such, cattle grazing continued throughout the year with nearly 17,500 acres being grazed at some time (Figure 2). The primary goal of the grazing program is to minimize tumbleweeds and manage excessive growth.

Tumbleweeds are an exotic pest which crowd out native species and create significant maintenance problems after wind storms. Cattle will graze on young palatable plants and in some cases trample older plants helping to minimize this problem.

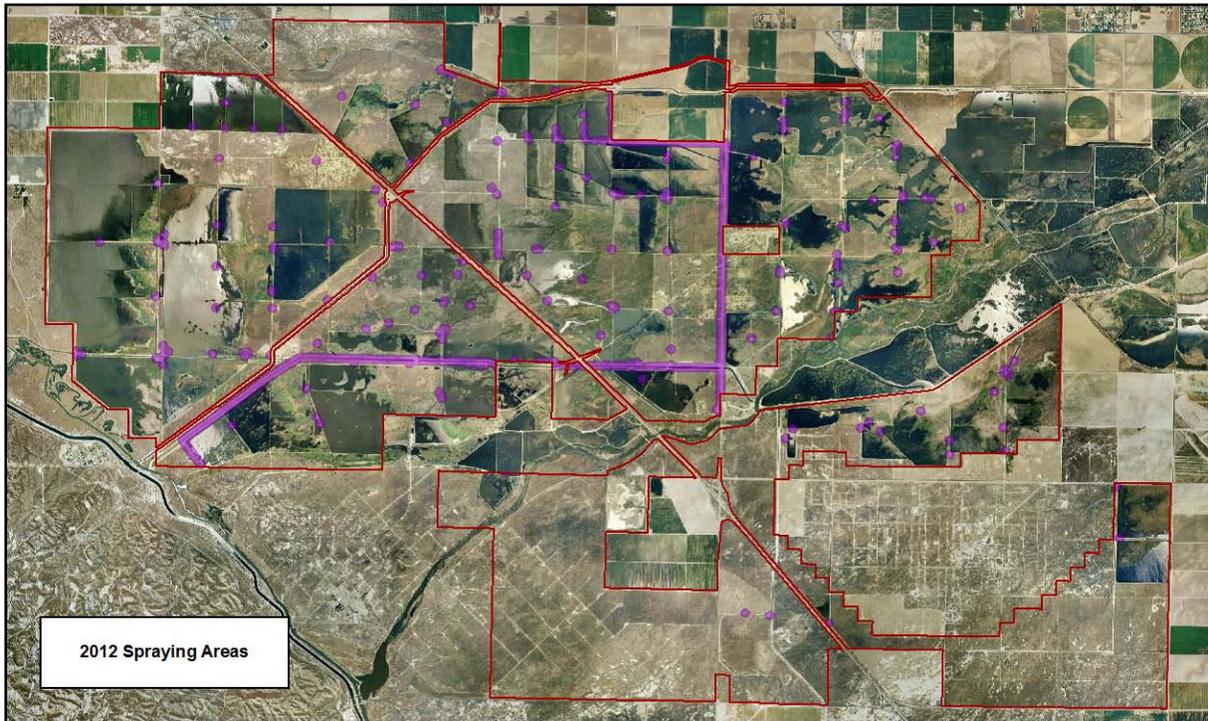
Figure 5. Areas sprayed in 2012.

Herbicides (Diuron and Round-Up) were used to control weeds at well sites, along roads, and at water control structures (Figure 5).
